# Special Report 31

## Snow Studies and Other Observations - Operation King Dog, Sondrestrom, Greenland

# **Snow Studies and Other Observations - Operation King Dog, Sondrestrom, Greenland**

by Chester C. Langway, Jr.

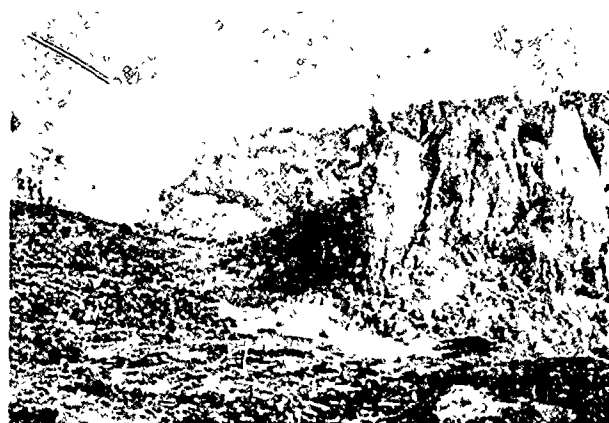
Figure 3. Snout of Russell Glacier showing pinnacled nature of the ice surface. The cliff face is approximately 160-180 ft high.  
27 March 1958.

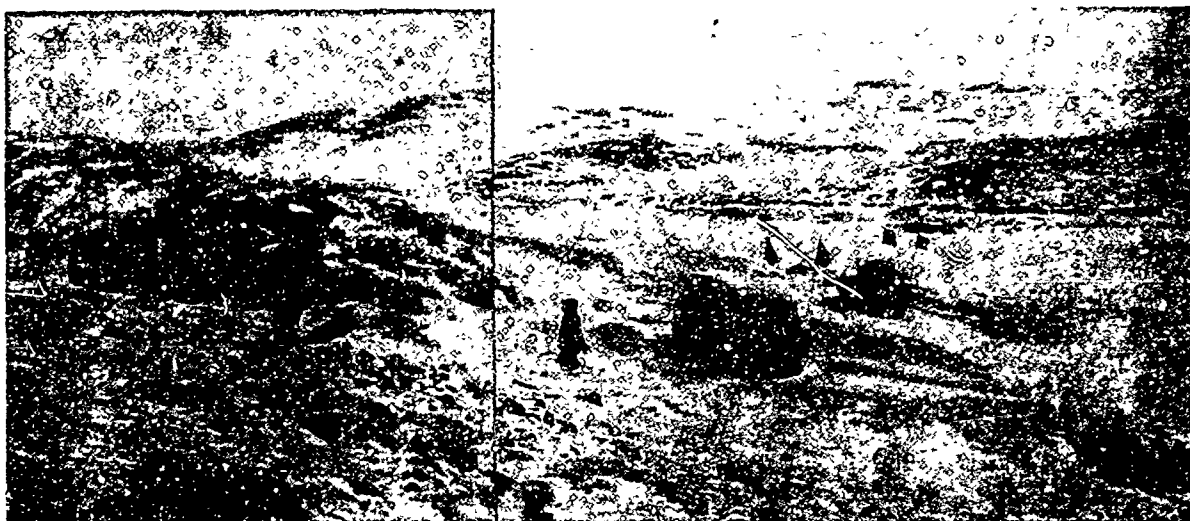
Figure 9. Skirting around bedrock outcrops at the snout of the Russell Glacier. Looking north, Russell Glacier is to the southeast. 28 March 1958.

(1) Approximately one mile north of the survival shack is a section  $1/4$  mile long, where a boulder field and angular rock outcrops presented some difficulty for weasel travel (Fig. 9). The danger of throwing a track always exists when crossing this type of terrain with a weasel, so great care was exercised here. With an adequate snow cover (about 1 ft) no improvement of this section would be necessary, but there were only 2 to 4 in. of snow during this period. Very little work would be necessary to improve this condition; a standard D-8 tractor with a blade might be sufficient.
